GROUP 7 COOLING SYSTEM

COOLING SYSTEM

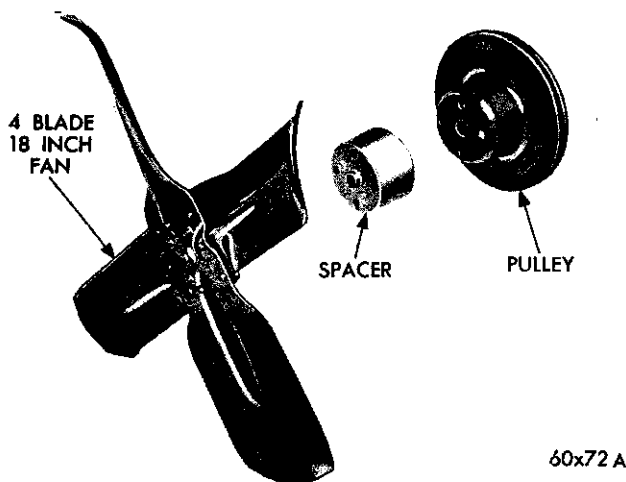
Fig. 1—Standard Fan Drive

Models with standard equipment have a 4 blade, 18 inch fan, as shown in Figure 1. Models equipped with air conditioning have 7 blade, 18½ inch fan, on the VY-1 and an 18 inch fan on the VC-1, VC-2 and VC-3 as shown in Figure 2. All VC-2 models with Fire Power 390 engine have a 7 blade 18 inch diameter fan.

The spacer (Fig. 1) used on VC-1, VC-2 and VC-3 models is 1.40 inch thick and on VY-1 models it is 1.60 inch thick.

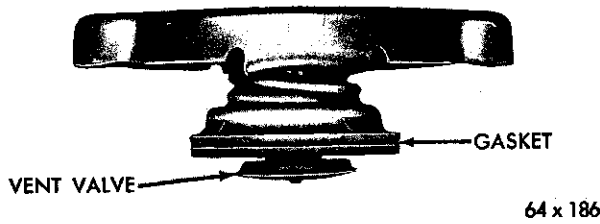
Fig. 6—Radiator Pressure Cap

Radiators are equipped with a 14 psi cap, as standard equipment and 16 psi with air conditioning, as shown in Figure 6. Always note the identification number on the cap when replacing.
